# GELCOAT BLISTERS

## A GUIDE TO OSMOSIS REPAIR

Repairing of fibreglass boats following osmosis damage with WEST SYSTEM ® Brand epoxy.

### **Catalogue No. 002-650**

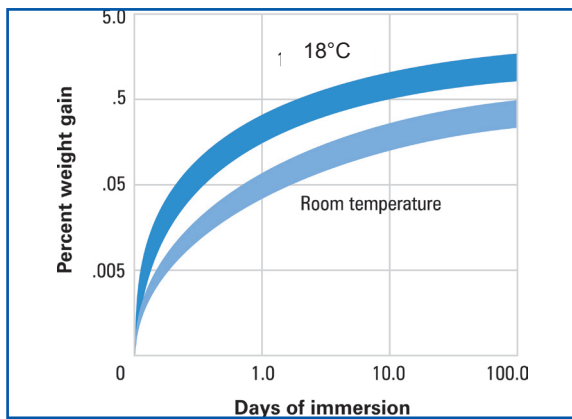
**Figure 2.4.** The susceptibility of a laminate to moisture permeation tends to increase with higher ambient temperatures.

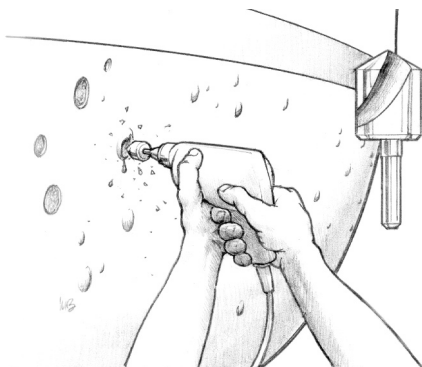
**Figure 4.1.** A variable speed drill with a countersink bit can be used to open blisters while providing good depth control

In some instances, good results have been reported when localised blisters have been opened, cleaned, dried and subsequently coated with unthickened epoxy, filled with thickened epoxy and then coated again with unthickened epoxy. Remember, however, that even though the localised problem may have been remedied, blistering and delamination may be occurring unnoticed in other parts of the hull. A more thorough approach would be to assume osmosis is extensive and that a complete hull treatment is necessary to overcome the problem.

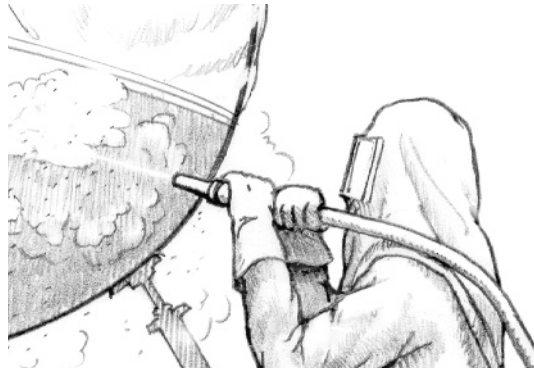
**Figure 4.3.** Sandblasting is a common method of opening blisters and abrading the hull

This method is also a potential health problem because of the airborne dust generated. Antifouling paint must be removed before sandblasting as failure to do so may result in small particles of paint becoming embedded in the laminate. This may create subsequent bonding problems.

Do not drive gelcoat particles into the softer, underlying laminate nor remove excessive quantities of the laminate. Remove between 90% and 95% of the gelcoat by sandblasting and then complete the process by sanding. After the gelcoat is removed, inspect the laminate for delamination and any further damage; sound the hull for voids.

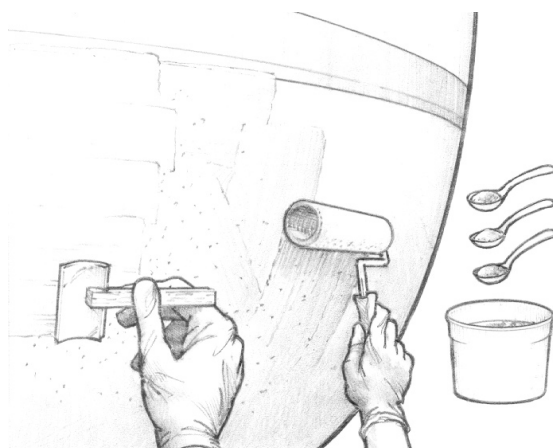
Figure 7.4. Add 422 Barrier Coat Additive to the second and remaining coats to increase moisture exclusion effectiveness and abrasion resistance.

**Note:** -To obtain a reasonably accurate addition of the filler, prepare a 260g batch of WEST SYSTEM epoxy (8 depressions of both the resin and hardener pumps) and, after blending, add 3 full tablespoons of 422 Barrier Coat Additive to the epoxy mixture and stir thoroughly.

Alternatively, the correct quantity of Barrier Coat Additive can be regularly achieved by weighing 55g of the additive into a paper cup and then cutting the cup down to the level of the powder. This technique is much preferred as it will ensure an accurate and consistent weight of filler is added to the epoxy mix and the “measuring” operation will be quicker.
